OXFAM IN ACTION: NEPAL FLOOD AND LANDSLIDE RESPONSE 2024

Oxfam In Action: Nepal Flood and Landslide Response 2024

Production: Oxfam in Nepal

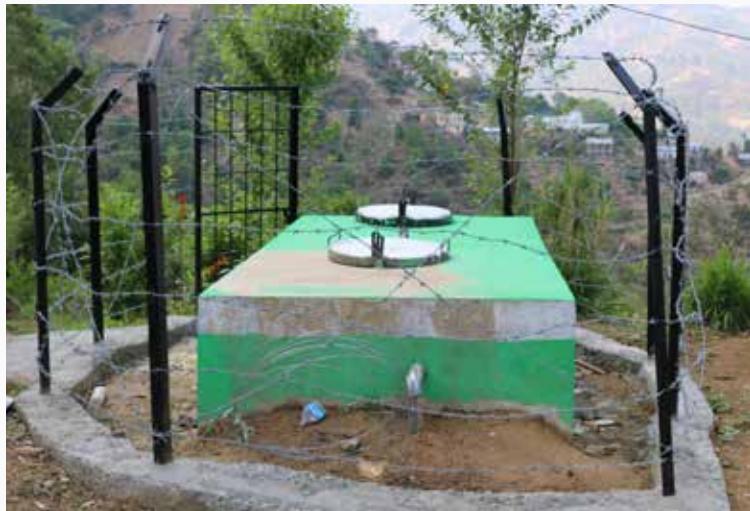
Newly constructed water reservoir under Bhakundebesi WSS

Three new water sources were identified, and a joint plan was put into action. Oxfam and SJASK supported the construction of intake structures at these sources, a central collection chamber, an interruption chamber, a 59-meter suspended crossing, and a 4 km transmission pipeline using HDPE pipes.

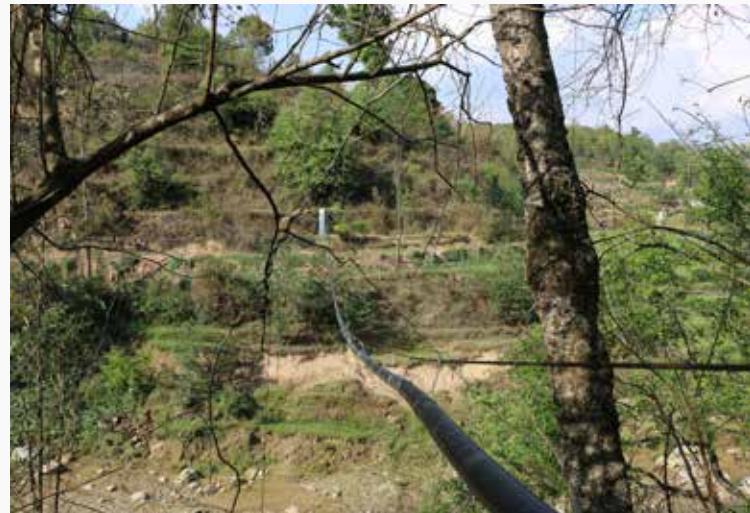
Water transmission line crossing over the river

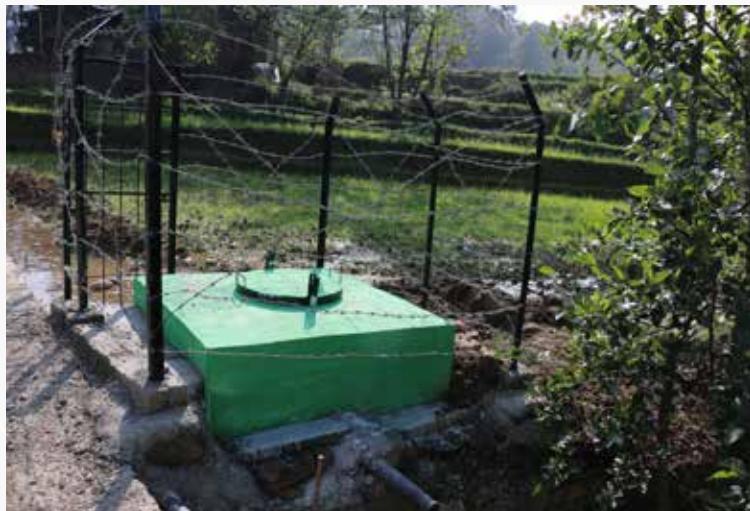
An interruption chamber chamber constructed under Bhakundebesi WSS to maintain water pressure

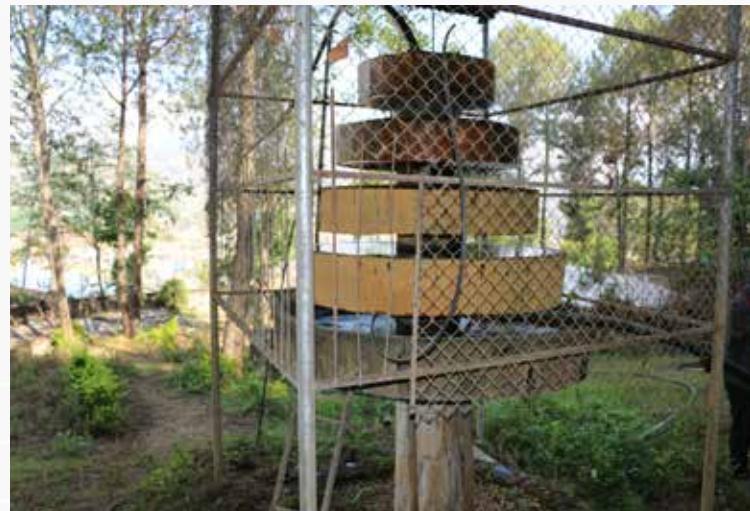
Bhakundebesi WSS water filtration plant

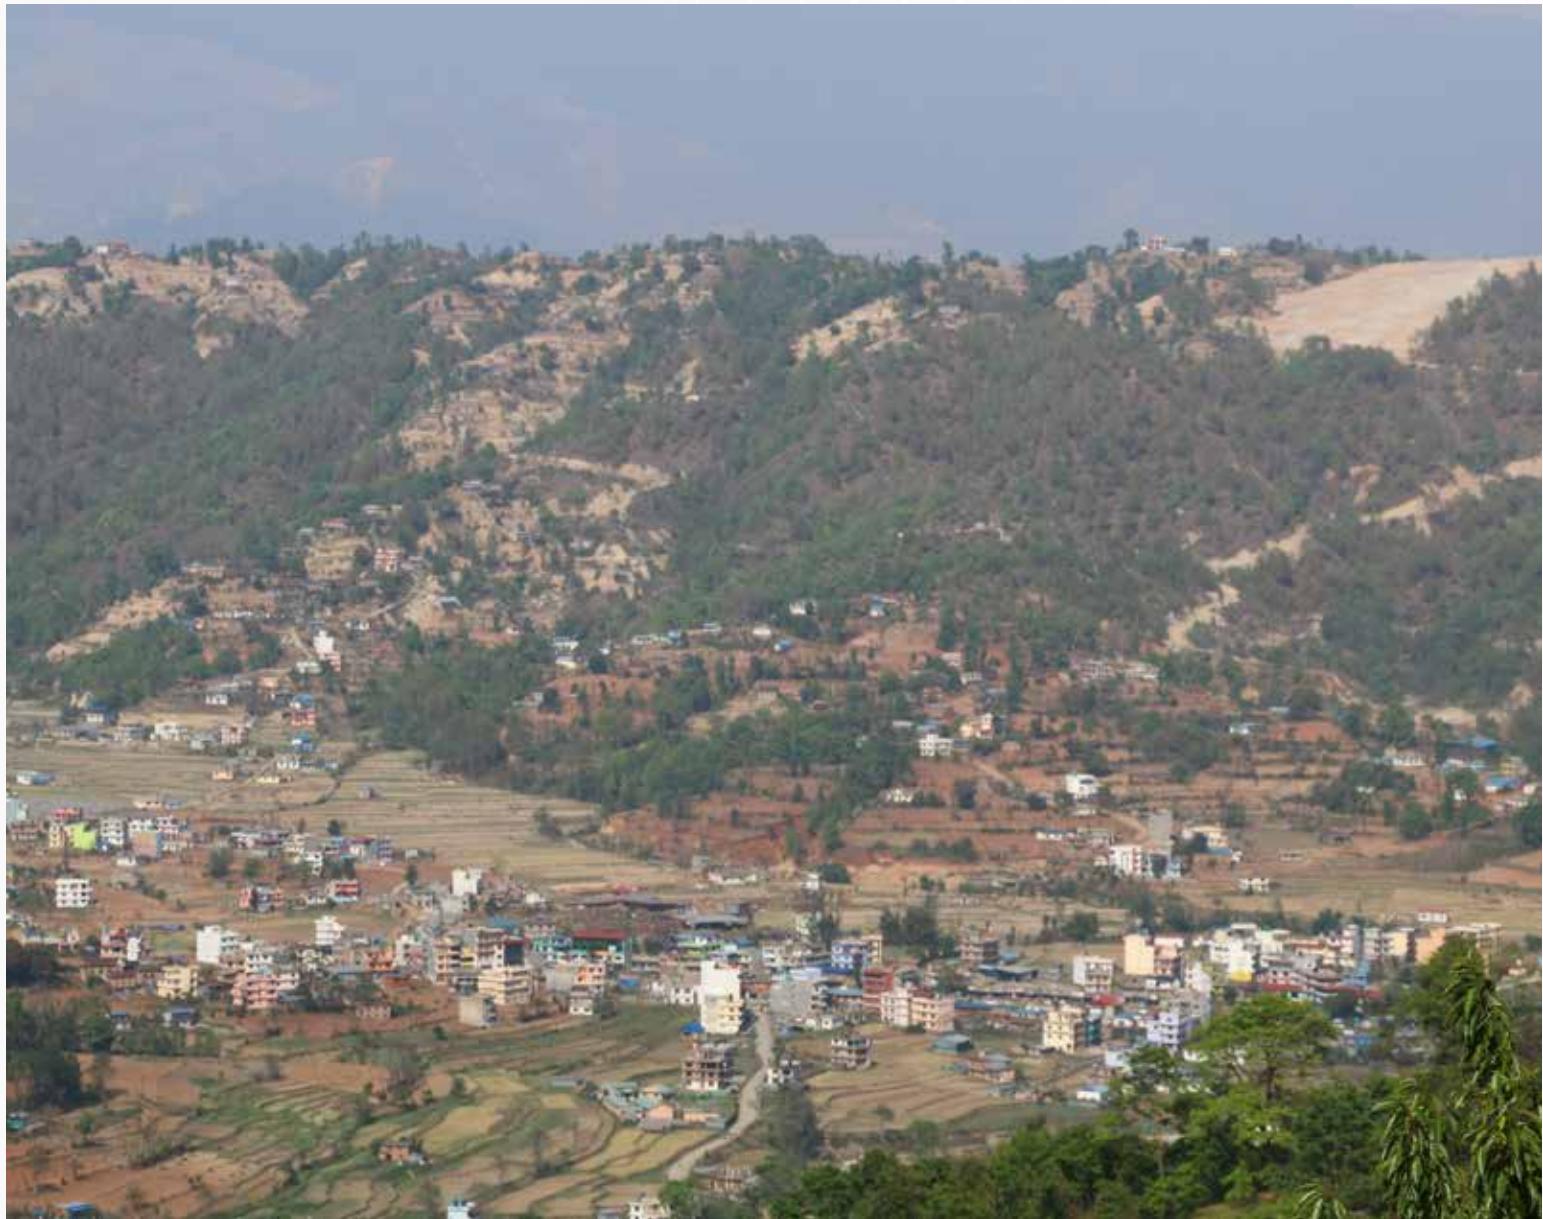
The repaired Bhakundebesi Water Supply and Sanitation Scheme (WSS) meets the drinking water needs of 410 households of Bhakundebesi Bazaar.

The water supply scheme's capacity has nearly doubled with the new sources, now collecting 86,400 liters of water daily (2 liters per second for 12 hours).

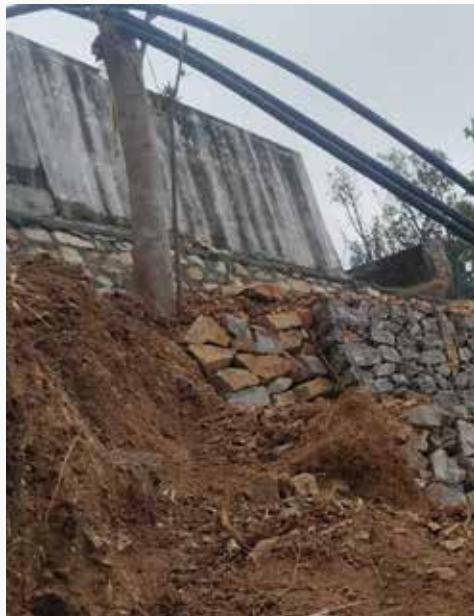
A landslide had completely destroyed Kunekharka Water Supply and Sanitation Scheme (WSS) in Bethanchok Rural Municipality-3, Kavrepalanchowk district, Bagmati Province.

The reservoir tank of Kunekharka WSS on the verge of collapse due to the landslide. The landslide took way the earthen foundation across the edge of the reservoir.

The repair and maintenance work of the scheme was completed at a total cost of NPR 1,642,740 with Bethanchok Rural Municipality contributing NPR 427,265, Oxfam provided NPR 1,100,000 in financial support (with technical assistance from Shanti Janadarsha Sewa Kendra), and local community labor contributing NPR 115,475.

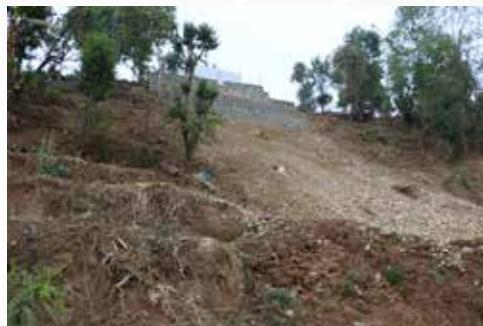
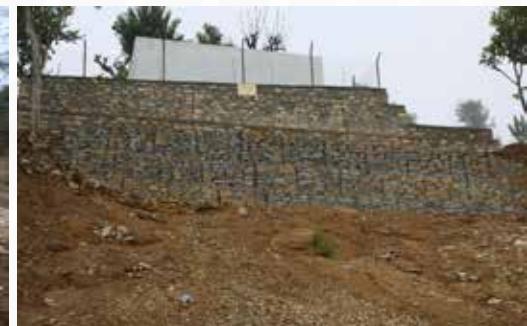
The repaired water reservoir with the protection wall under Kunekharka Water Supply and Sanitation Scheme (WSS). The structure was buried and damaged in mud by the landslide.

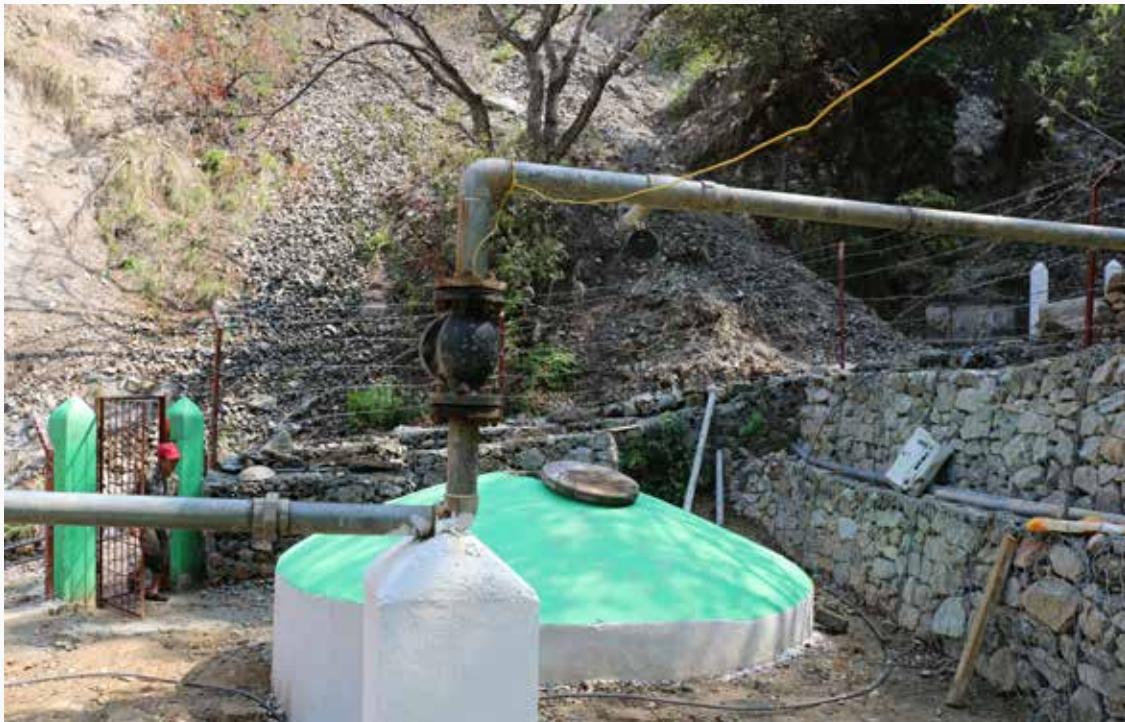
51-year-old Village Maintenance Worker and self-trained technician for the Sano Gimdi Lift Water Supply project, Man Bahadur Tamang, with SJASK's technical guidance, employed practical solutions to extensive damage. Instead of union sockets, he welded all 120 broken GI pipes for the lifting system. He also ingeniously used damaged pipes to form hooks and bracing as anchors, replacing concrete blocks.

Oxfam and Shanti Janadarsha Sewa Kendra (SJASK) spearheaded the repair of the scheme, which was completed with a budget of NPR 1,061,354. These involved the rehabilitation of 108 meters of lifting GI pipes, the construction of a new pump house, motor repair, enhanced protection for the source and reservoir tank, and the installation of new electromechanical equipment. This ensures 150 households now directly benefit from access to drinking water.

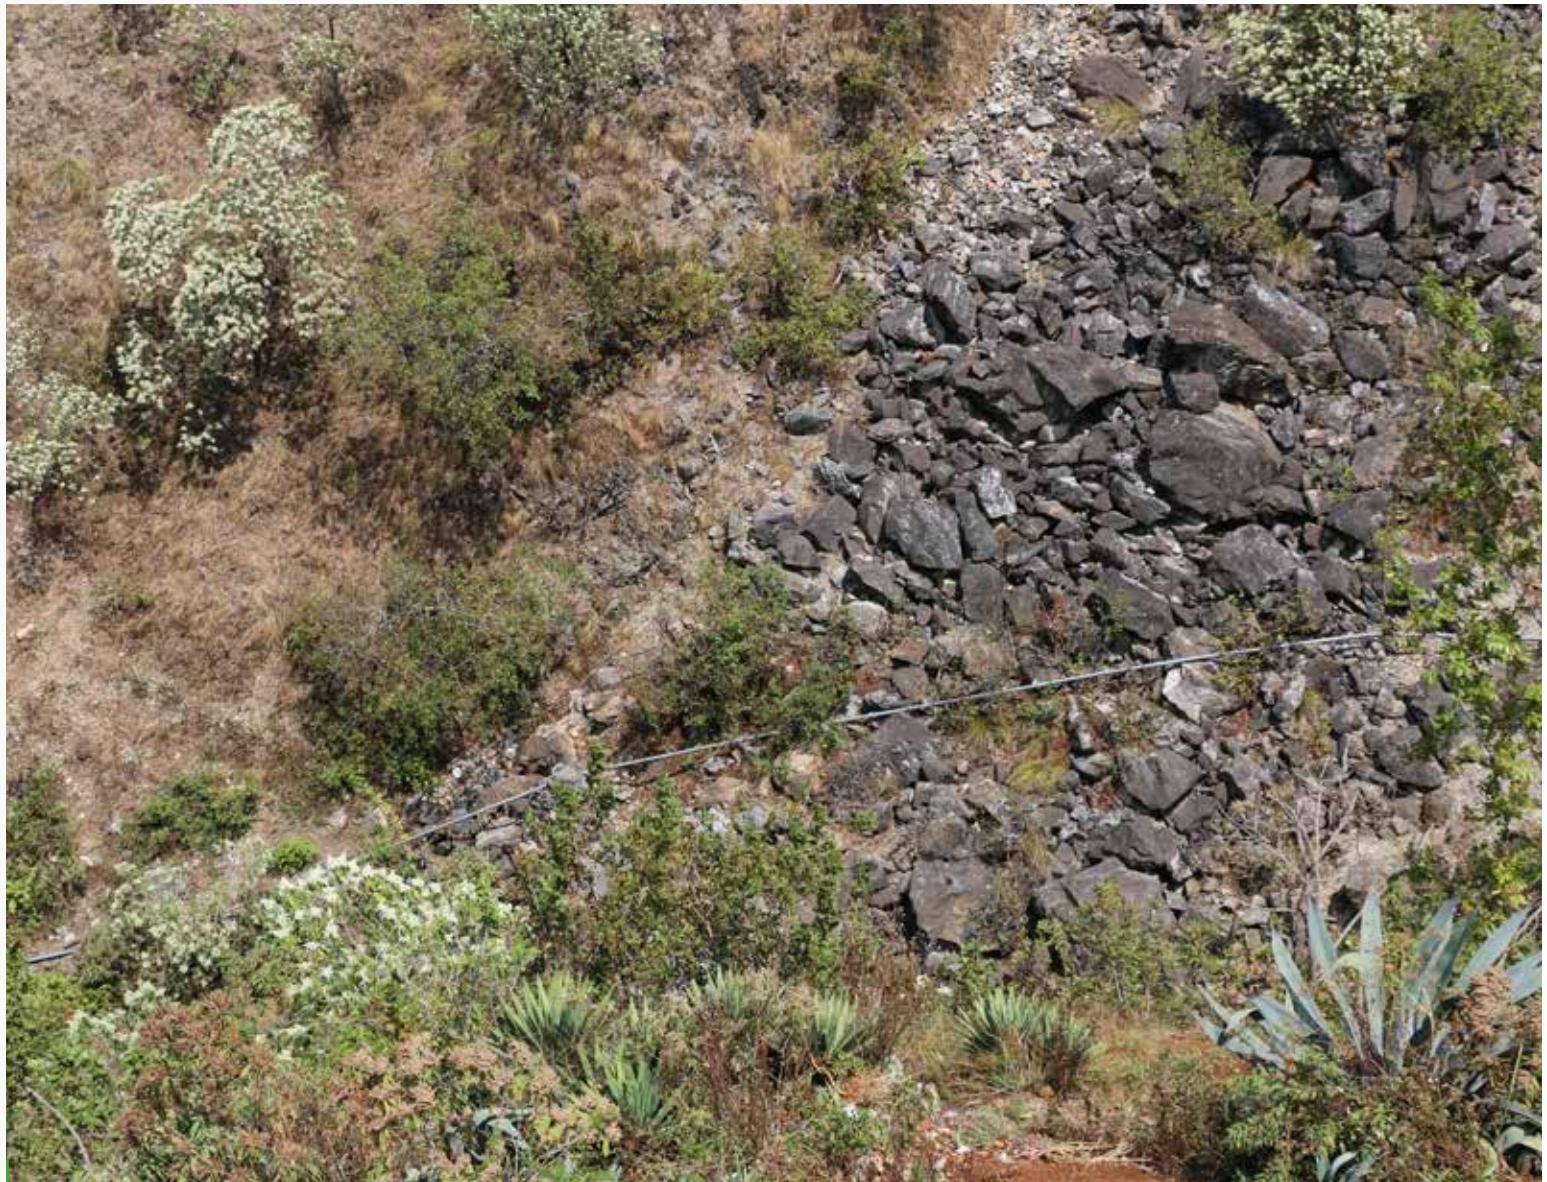
Given the area's high susceptibility to landslides, significant improvements were made to the water supply scheme.

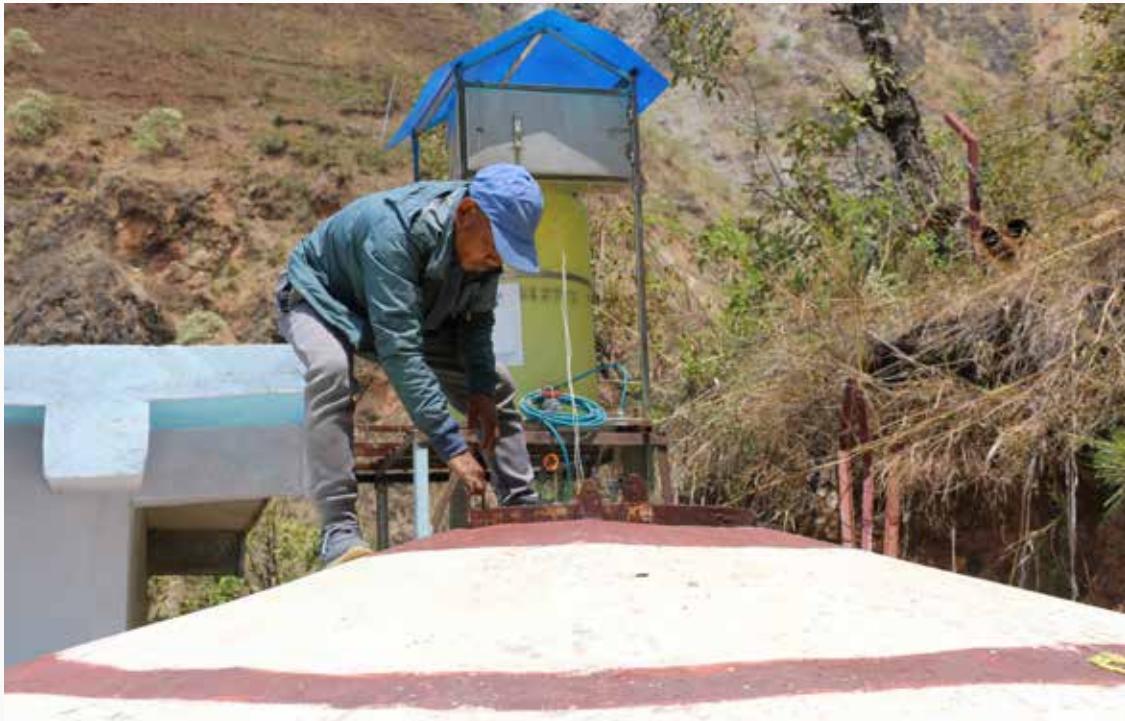
Man Bahadur Tamang uses mobile-based remote mechanism to operate and control the lifting system.

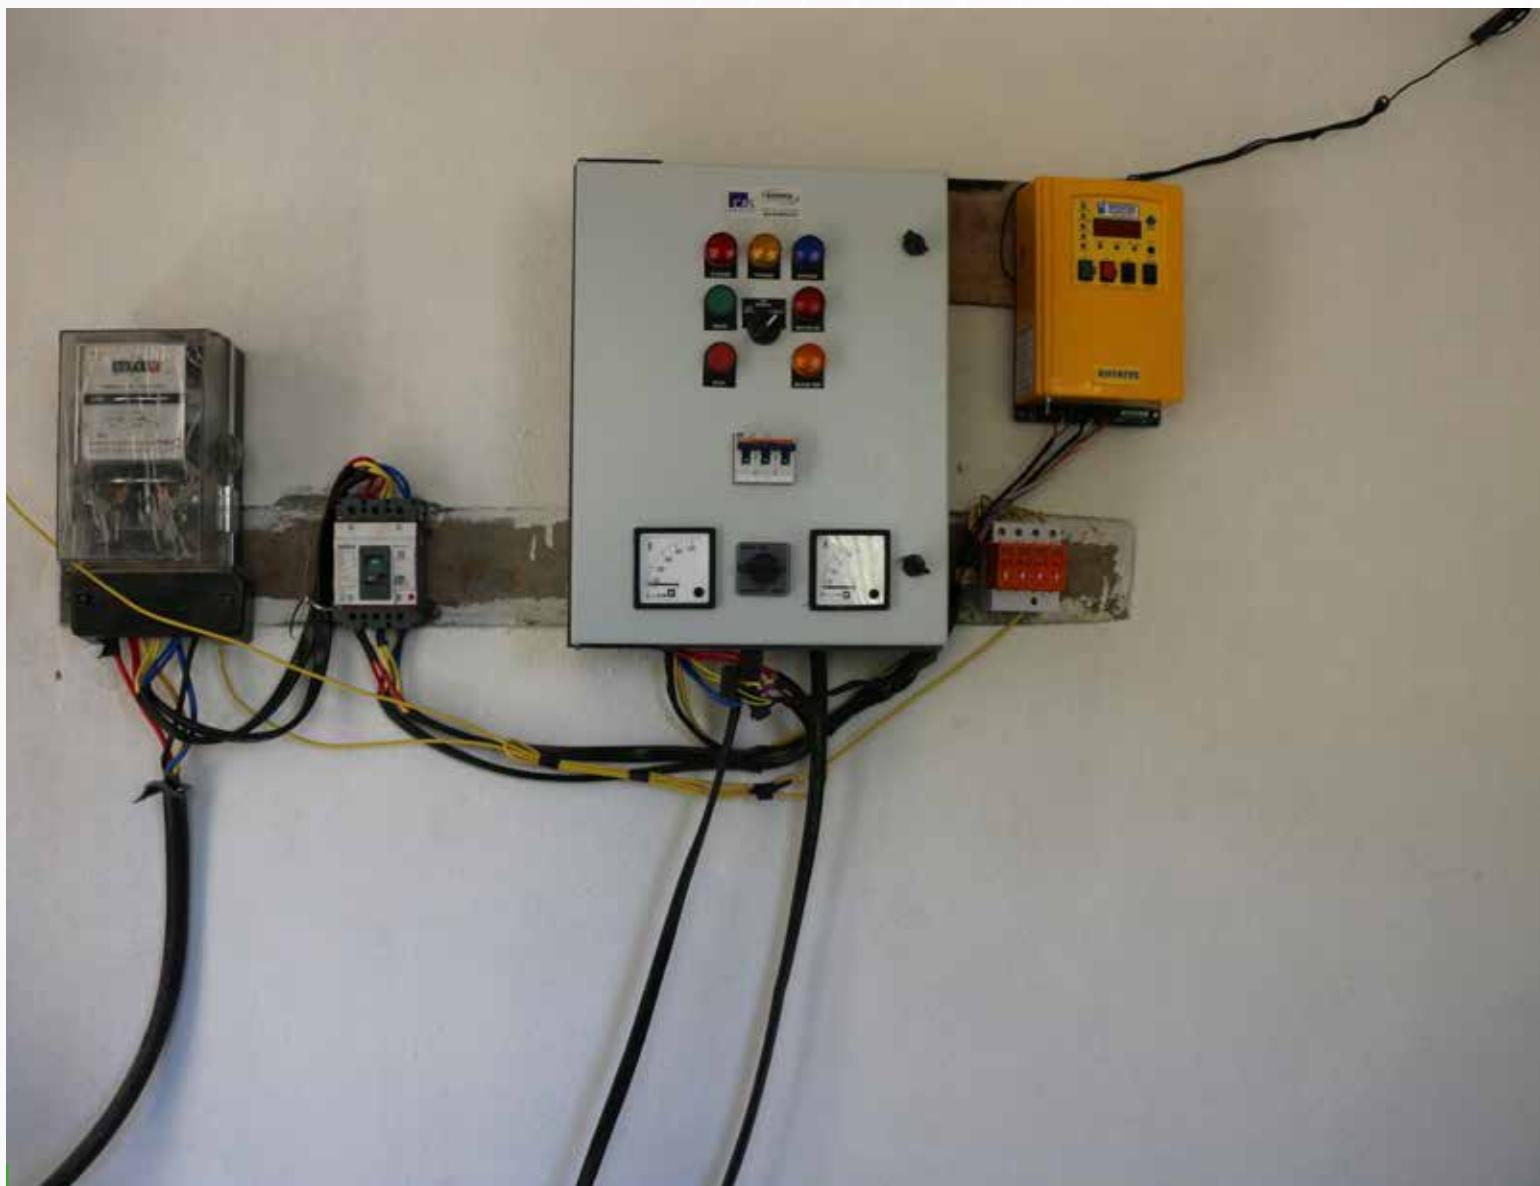
The new pump house now features newly installed electromechanical and remote-mobile based control system.

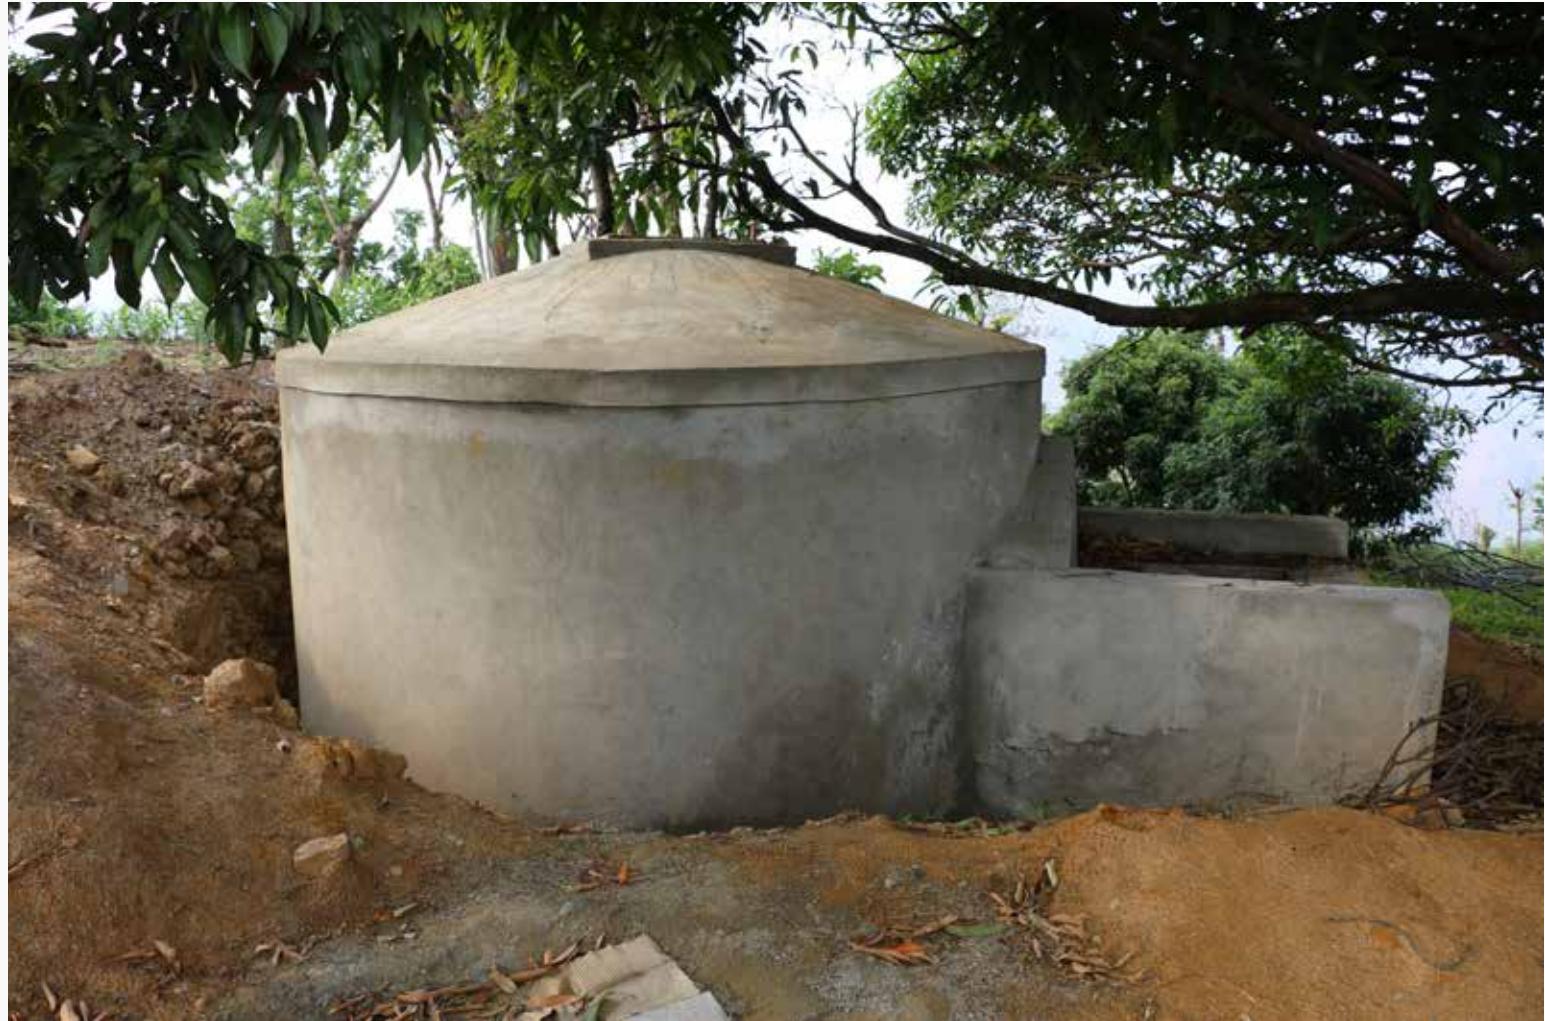
In Janagau village, Benighat Rorang Rural Municipality-in Dhading district, Bagmati Province, landslide swept away the transmission lines of a crucial water supply scheme. To restore drinking water to this remote village, Oxfam and Forum for Community Upliftment System (FOCUS) Nepal collaborated on repair efforts.

Newly constructed water tank as part of Oxfam and FOCUS Nepal's repair efforts.

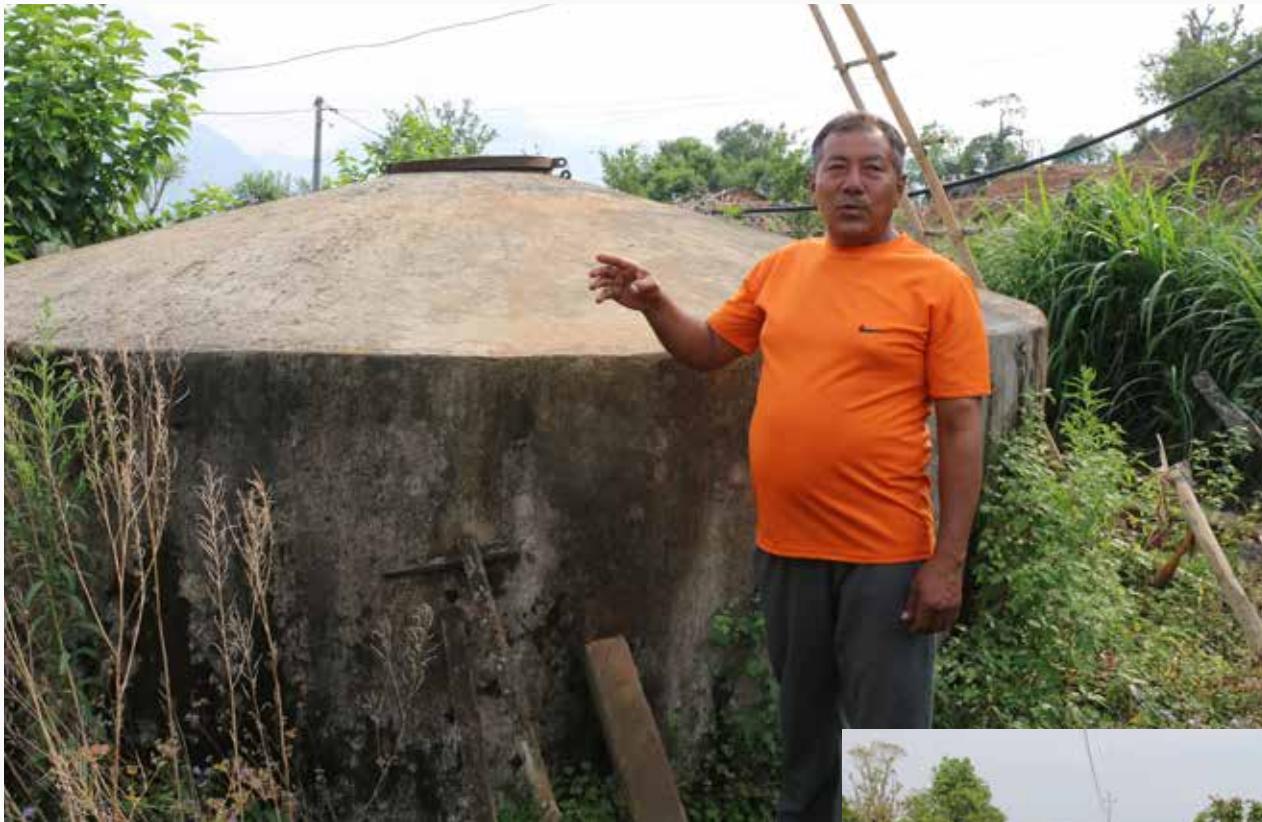
Man Bahadur Ghale, 52, from Janagau shows the old water tank.

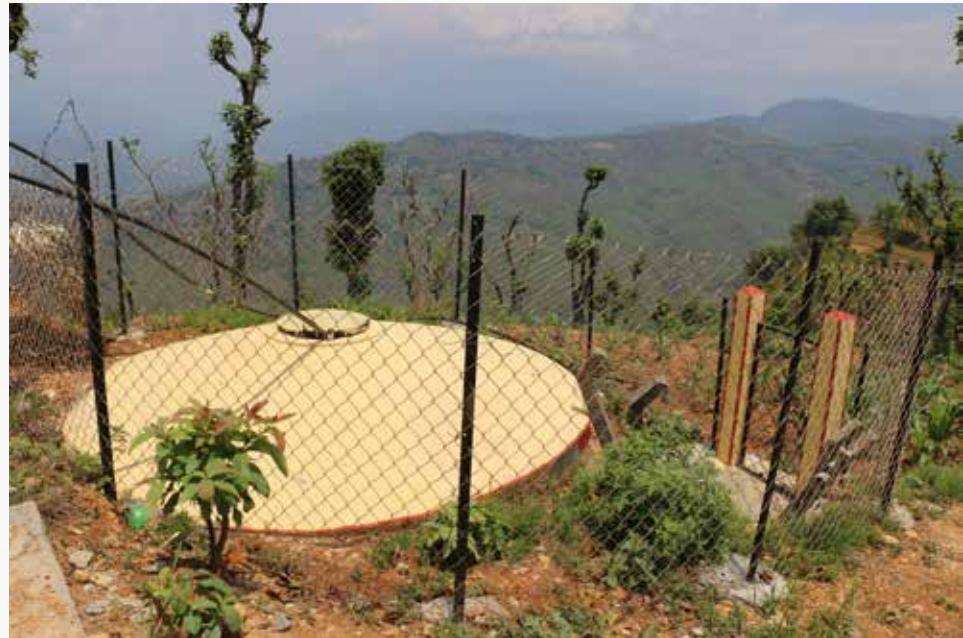
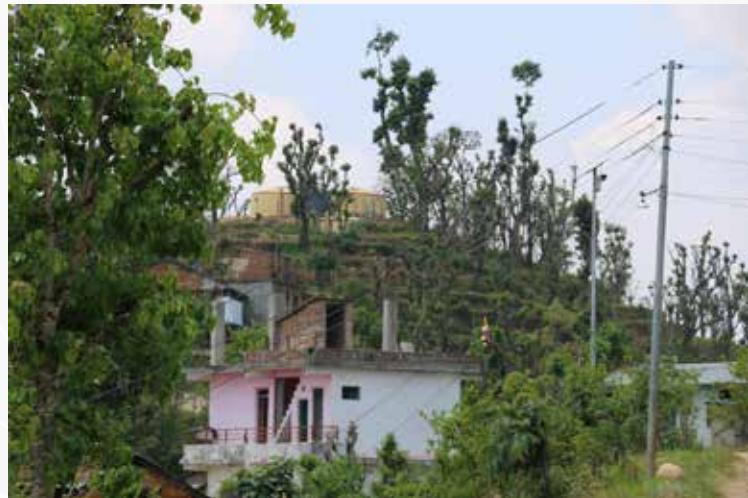
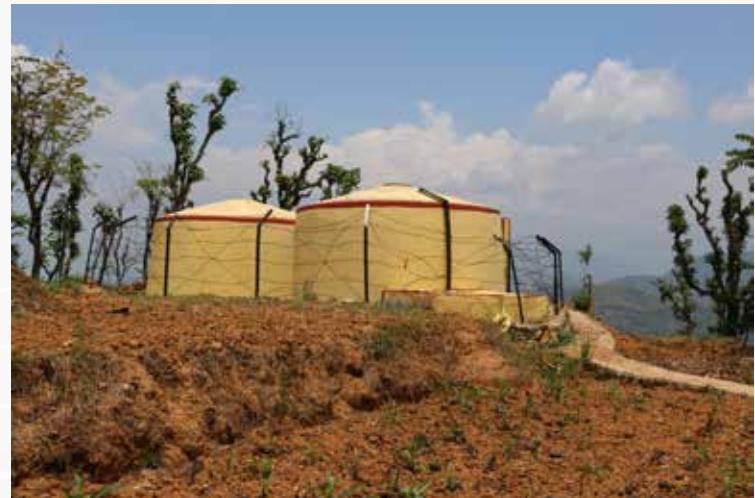
Newly constructed water reservoir in Khari, Jwalamukhi Rural Municipality-5, Dhading district, Bagmati Province with Oxfam and Forum for Community Upliftment System (FOCUS) Nepal's support

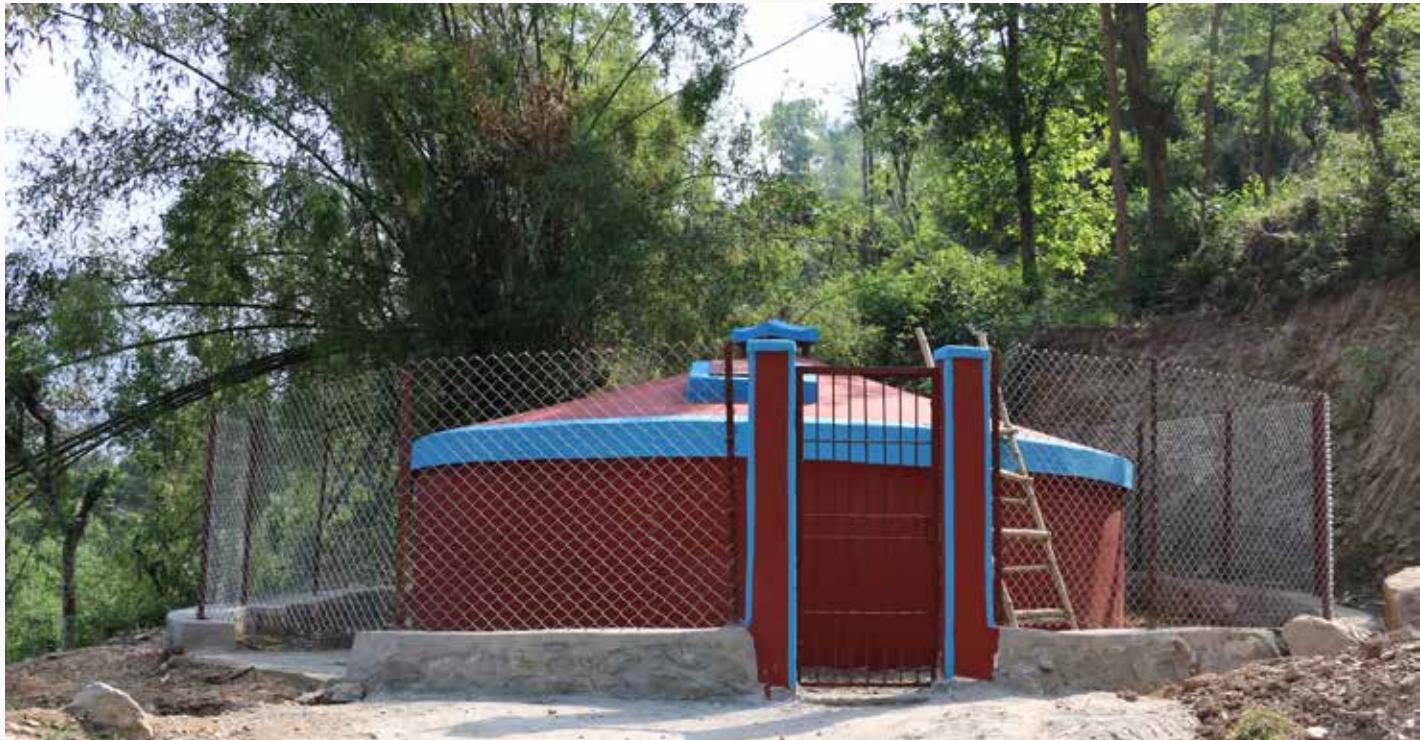
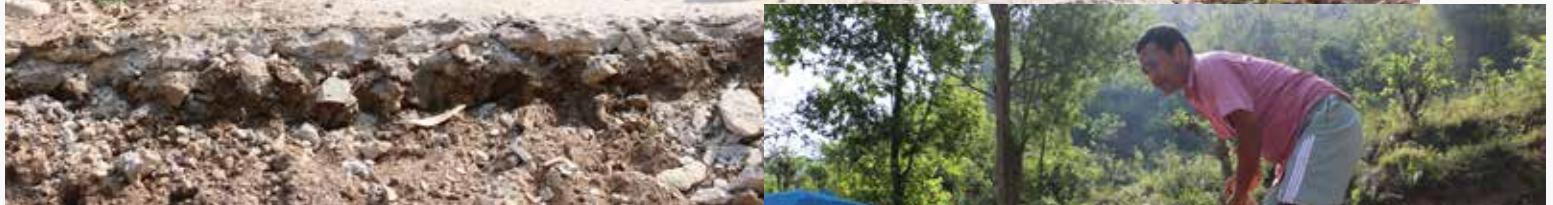
A new water reservoir has been constructed in Benighat Rorang Rural Municipality-7, Dhading district, Bagmati Province. This was necessary after the original reservoir was damaged by a landslide, which also affected the area's water sources.

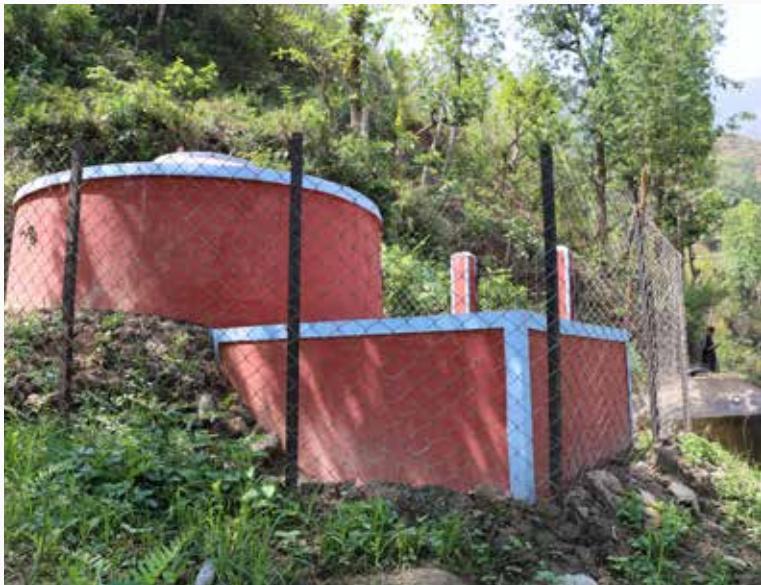
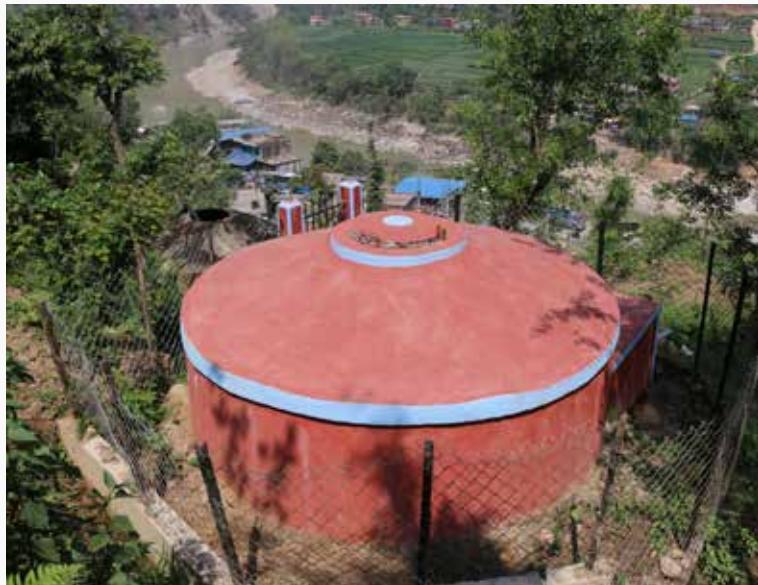
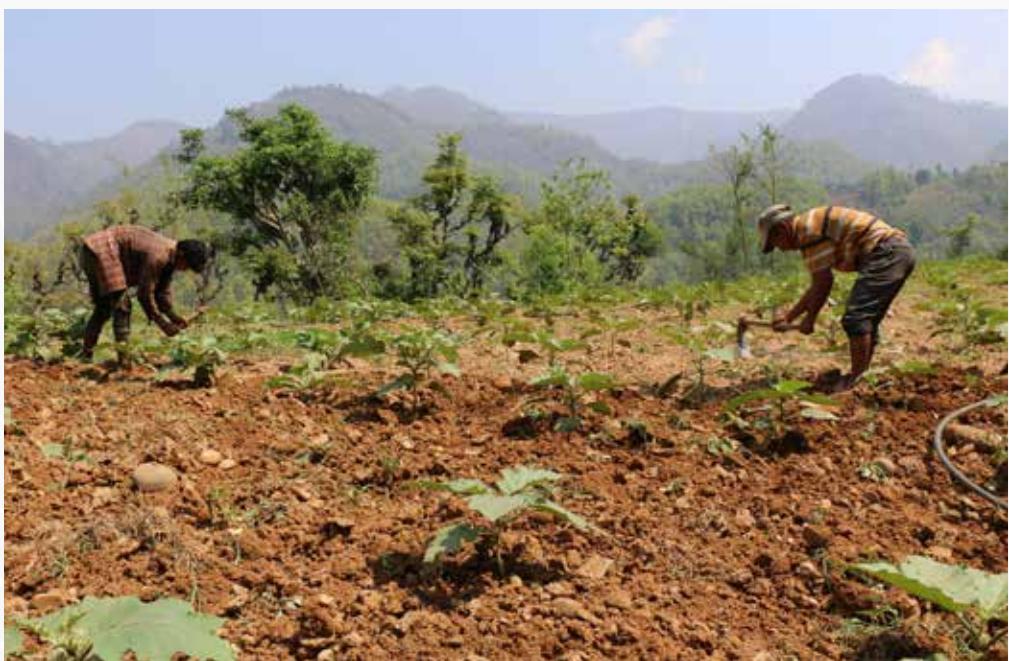
Another water supply scheme constructed in Benighat Rorang Rural Municipality, Dhading district, Bagmati Province.
Photo: Birkha Pun Magar/Oxfam

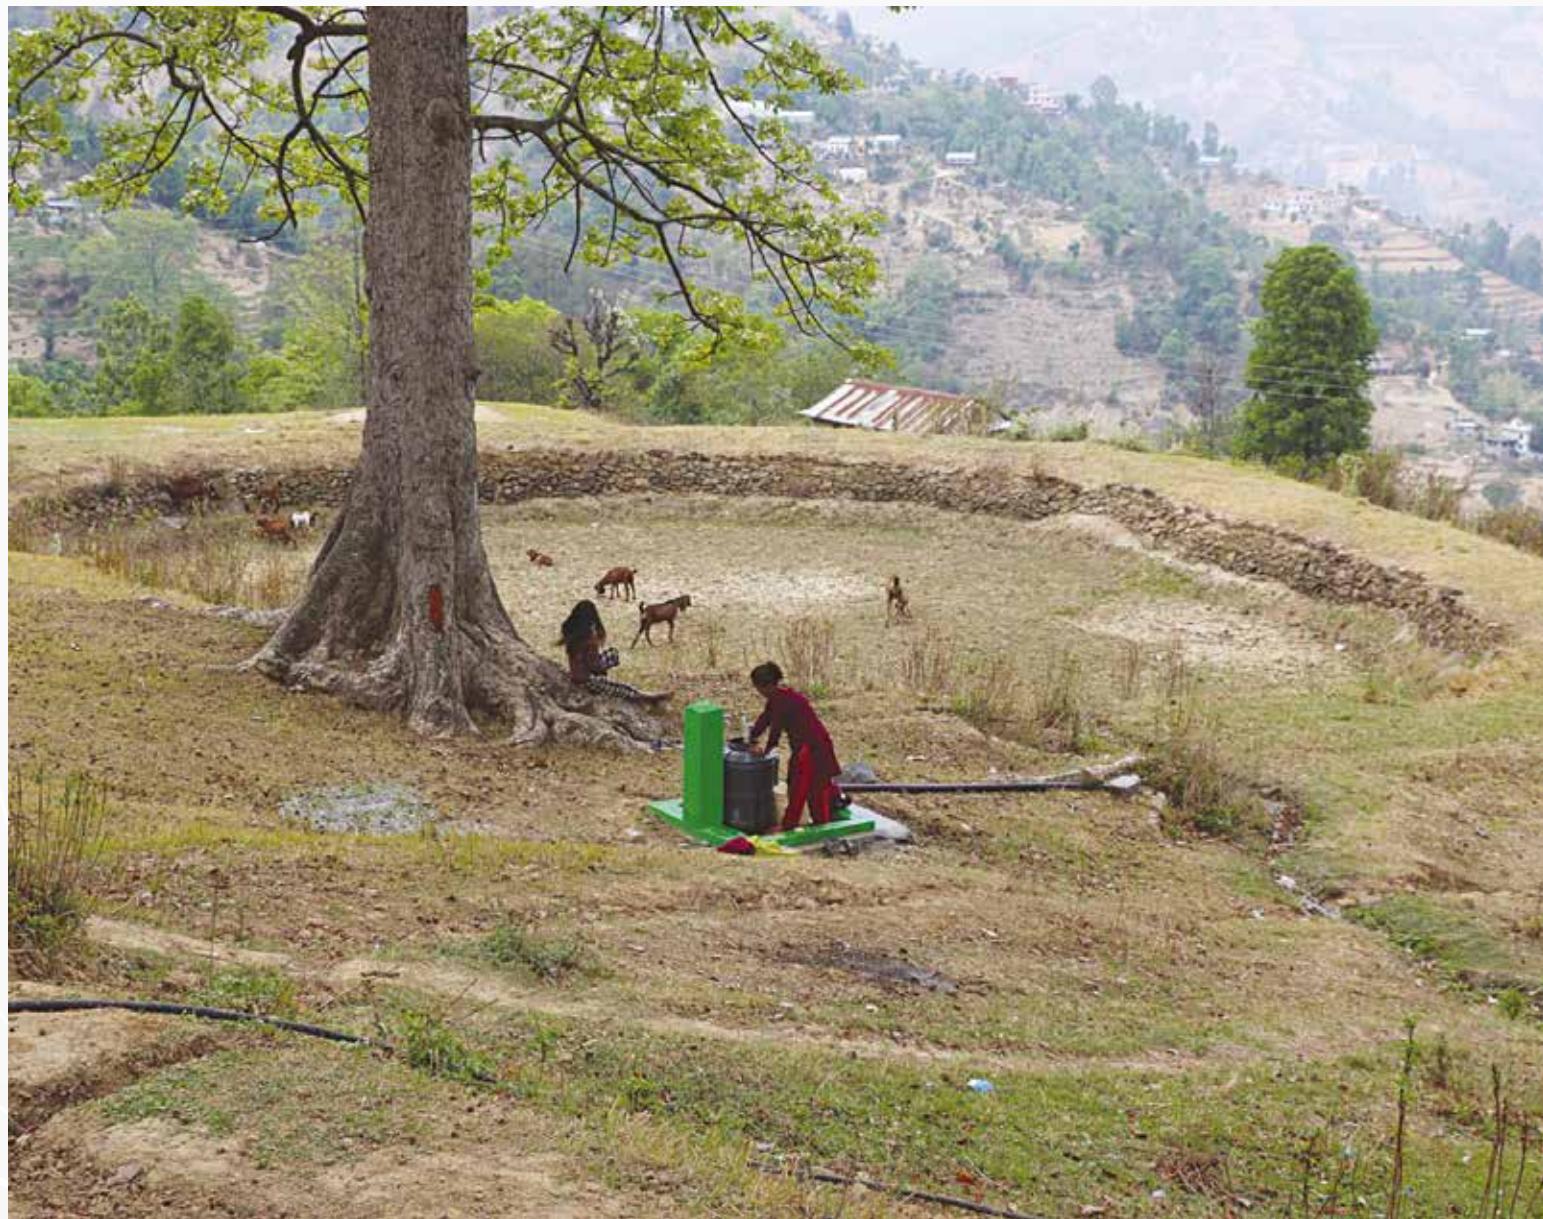
A shared tap built for three households of Aarubaari Chaur village.

Oxfam and SJASK stepped in to restore the water supply. The initiative included installing 600 meters of main pipeline from the source to a new 4,000-liter reservoir tank, and extending distribution lines. This effort was funded by a NPR 583,000 contribution from Oxfam and NPR 218,000 in community contributions.

Furthermore, eight private taps and one shared tap, which serves three households was also installed. This new water scheme will directly benefit 60 people, including three senior citizens and four new mothers.

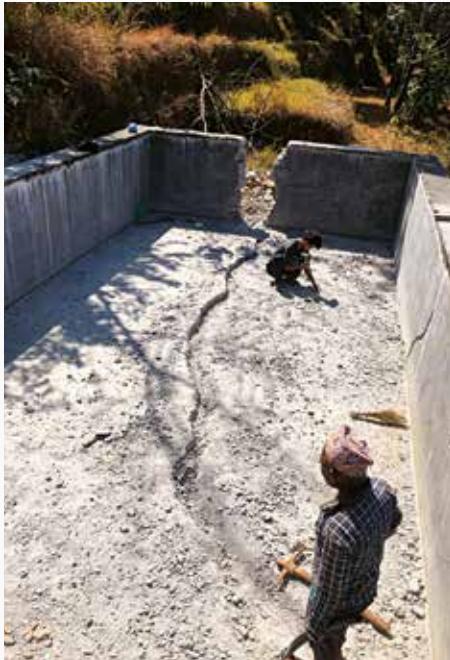
Before

The September flood severely impacted agricultural livelihoods in Temal Rural Municipality by destroying the irrigation canal and water reservoir of Gaderi Khola Irrigation. In response, a 700-meter canal, two 18x35 meter water ponds, and three distribution chambers were reconstructed. This vital irrigation system now directly benefits 160 farmer households, enabling them to irrigate around 40 hectares of land. Most of these households cultivate 0.40-0.50 hectares of vegetable farms, yielding approximately NPR 100,000 to 150,000 annually.

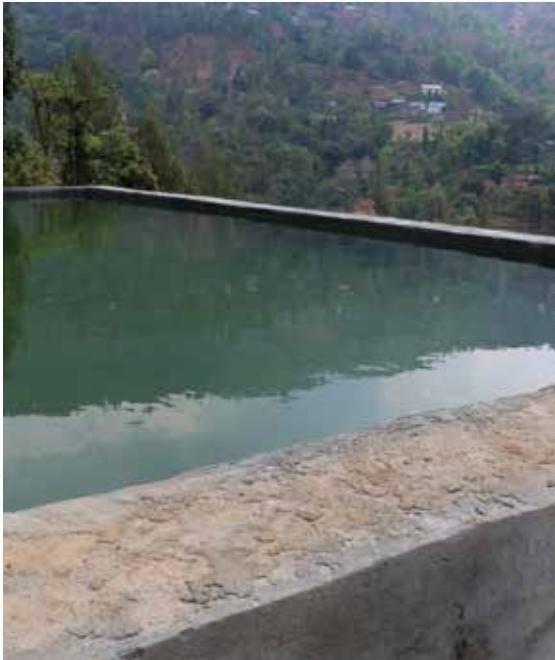
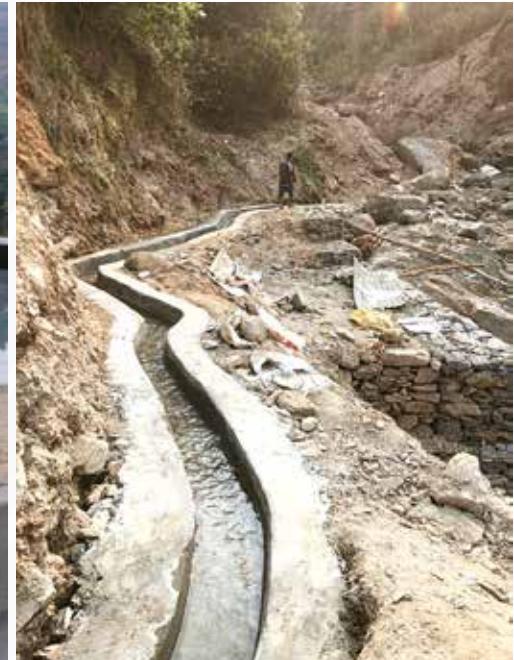
After

The newly constructed irrigation channel under the scheme.

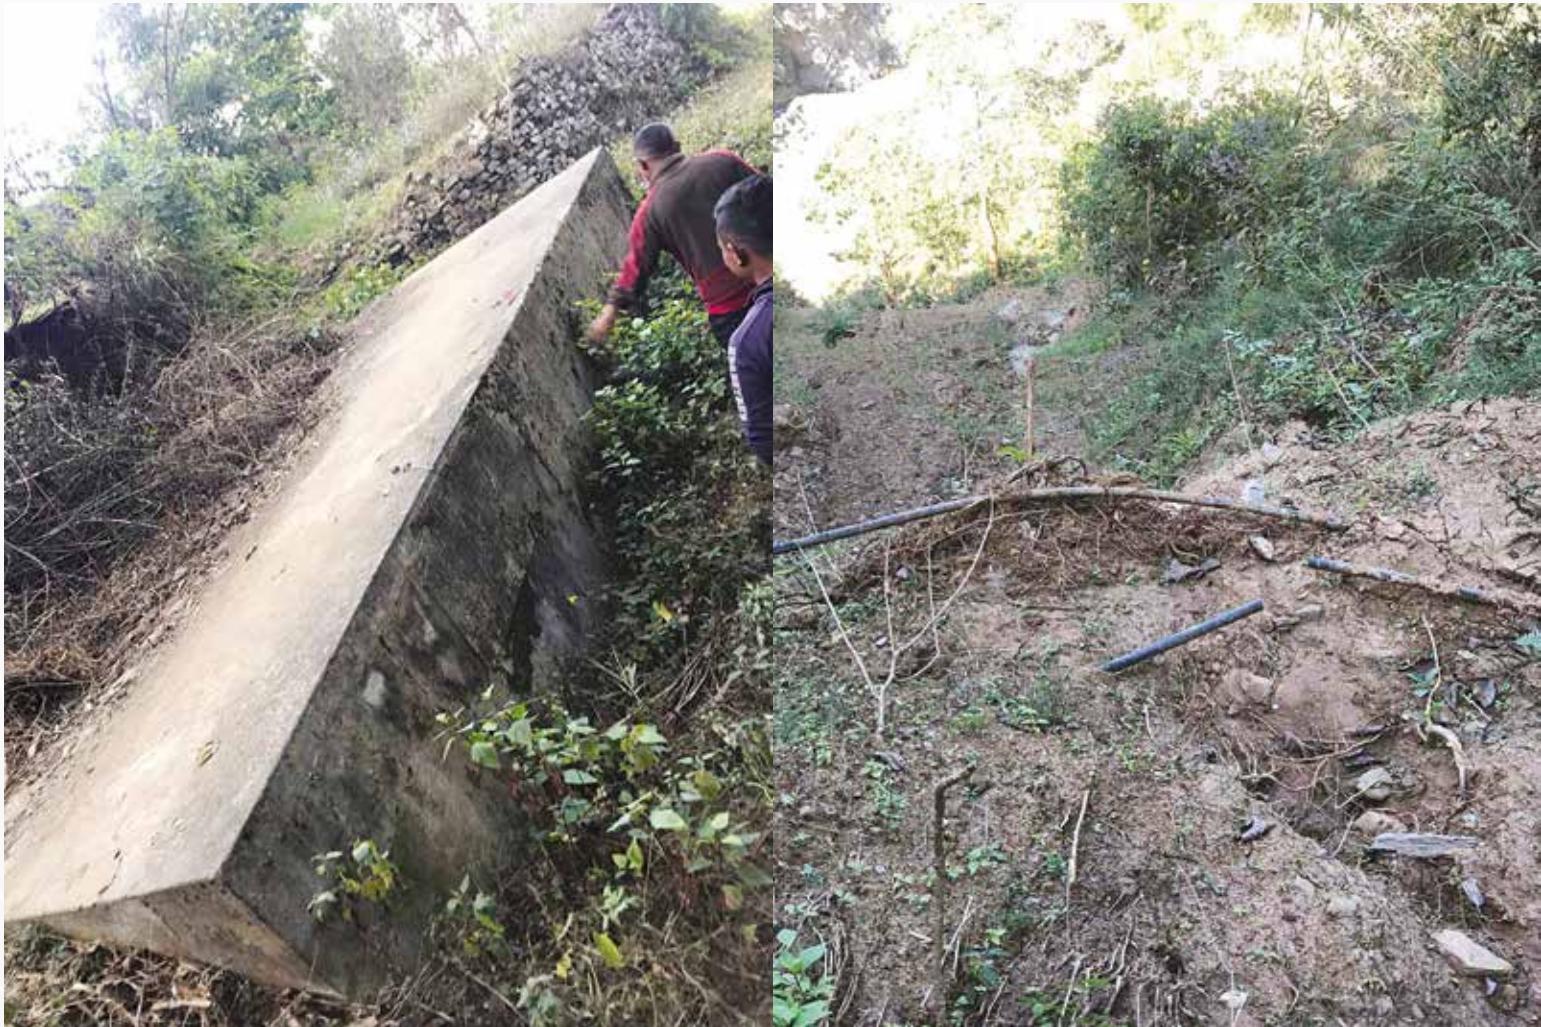
The landslide completely destroyed the reservoir tank and distribution pipelines, and the area was also covered in debris.
